# **INDOOR AIR QUALITY & WATER DAMAGE ASSESSMENT**

**Department of Agricultural Resources  
64 Century Way  
West Springfield, MA**

Prepared by:  
Massachusetts Department of Public Health  
Bureau of Environmental Health  
Indoor Air Quality Program  
December 2019

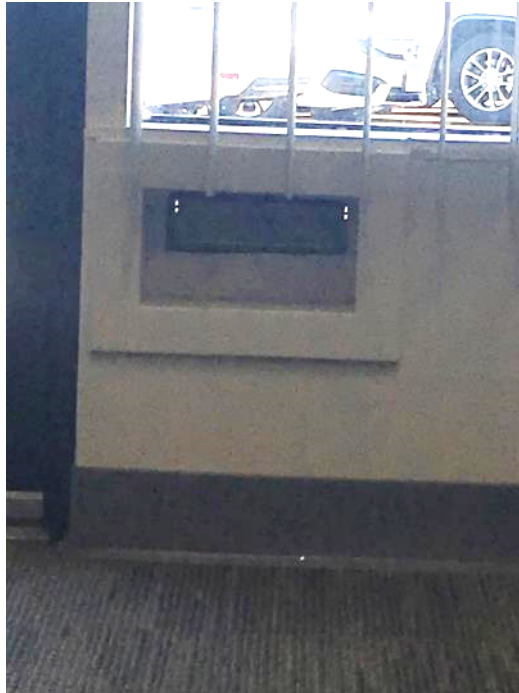
**Picture 1**

- A mailbox that is open to the outdoors exists in the conference room (Picture 1). This opening should be rendered air-tight and be properly insulated.
- The front and rear exterior doors have spaces beneath/around them.
- A significant length of the junction between the sidewalk and window panels is missing sealant (Picture 2).

**Mailbox in conference room**

1. Reapply a sealant to the window/sidewalk junction.
2. Install adequate weather-stripping and door sweeps to exterior doors.
3. Consider permanently sealing the mailbox in the conference room.
4. Move or remove any remaining items and furniture from the floor and away from walls in the affected areas to inspect underneath and behind them for additional water damage.
5. Water-damaged porous materials such as boxes/papers may need to be discarded if they show signs of mold colonization such as musty odors.
6. Increase cleaning in the affected areas to remove dust and debris from carpeting and flat surfaces. Clean carpeting and surfaces thoroughly once the rest of the remediation is completed.
7. Consider adopting a balancing schedule of every 5 years for all mechanical ventilation systems, as recommended by ventilation industrial standards (SMACNA, 1994).

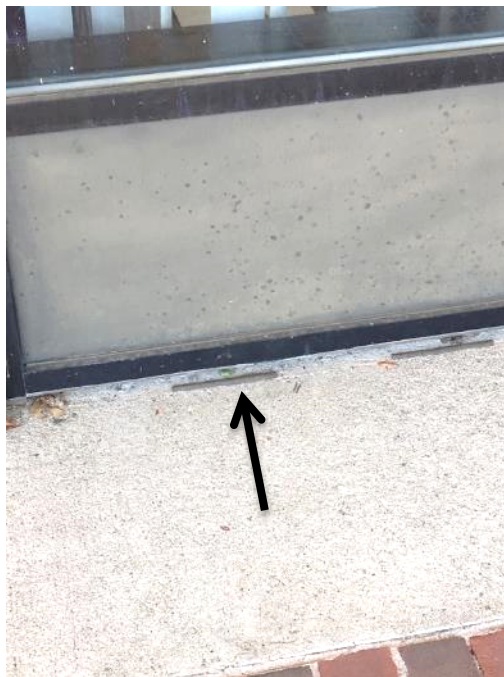
**Picture 2**

**Missing sealant on sidewalk/window panel junction  
(Arrow shows old/discontinuous sealant)**
